Occupational Radiation Protection during High Exposure Operations

Lessons Learnt from Occupational Radiation Protection
in Past Accidents

Radiological Accidents – Samut Prakan Accident

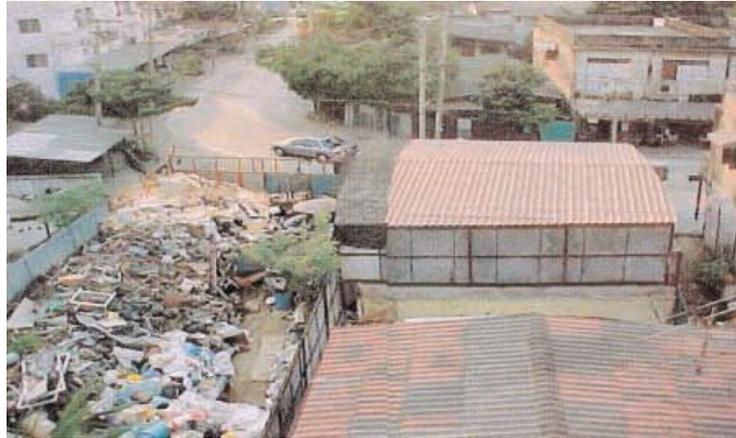
Elevated view of the junkyard.

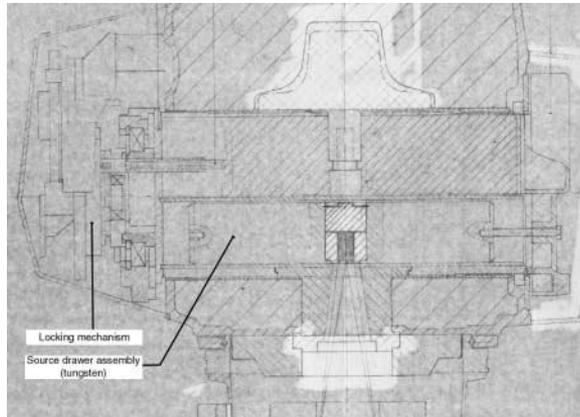
The Siemens Gammatron-3 teletherapy head (cutaway side view). The lighter area in the centre is the source.

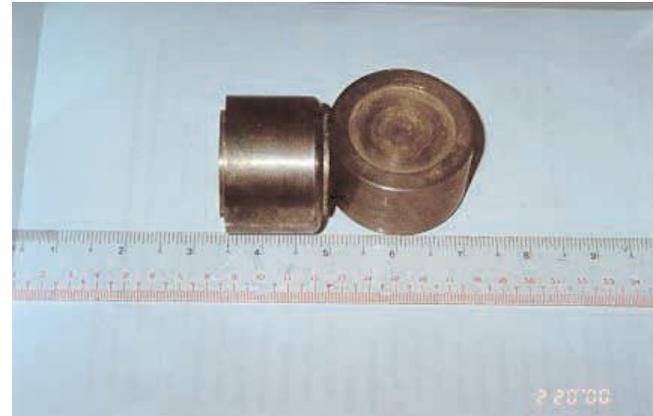
Cylindrical pieces from the source assembly (the item at left is hollow; it previously surrounded the ^{60}Co source)

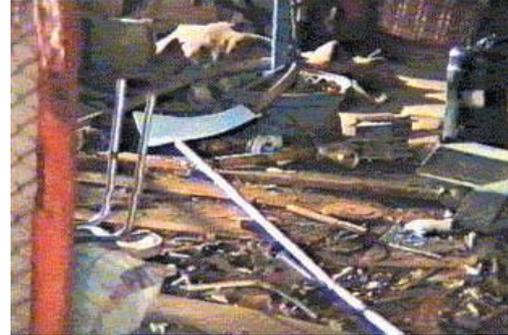
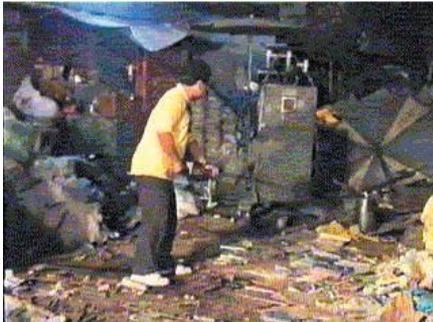
Transfer of the retrieved source to a shielded transport container

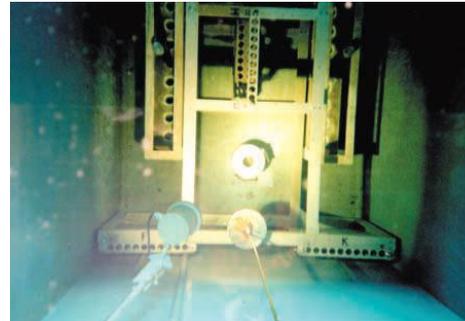
Storage location of the retrieved source
